**2005 Operations, Maintenance,
and Monitoring Report**

**BARATARIA BASIN LANDBRIDGE
SHORELINE PROTECTION
PROJECT (PHASES 1, 2, 3, and 4)**

State Project Number BA-27, BA-27c, BA-27d
Phase 1, Priority Project List 7
Phase 2, Priority Project List 8
Phase 3, Priority Project List 9
Phase 4, Priority Project List 11

June 2005
Lafourche & Jefferson Parishes

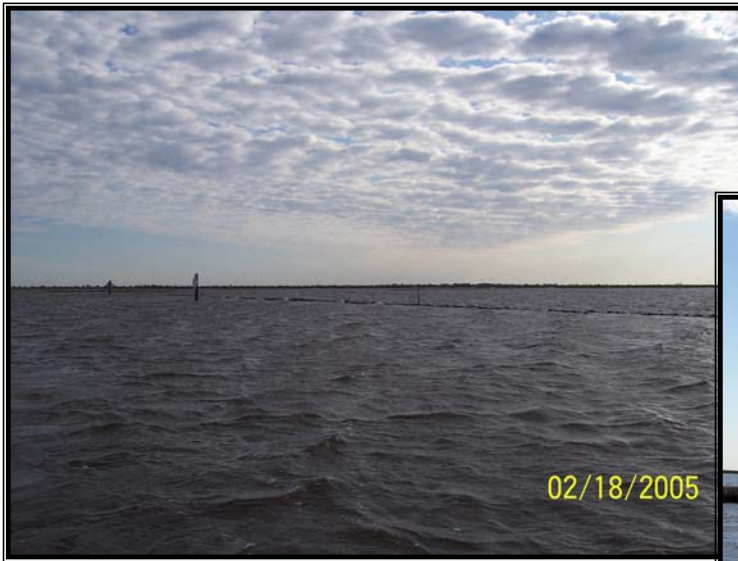
Section C – The composite rock dike by furrow method has settled approximately 3.5 ft (1.1 m) since the structure was completed in July 2001.

BA-27 (Construction Unit No.1), 400 linear ft (122 m) composite rock dike (furrow method) located along the east bank of Bayou Rigolettes near the Harvey Cutoff Canal looking southeast.

Section C - nearly all of the composite rock dike with furrow method was below the existing water elevation of 0.8'. The rock dike has settled in excess of 3'.
					Section D -concrete pile and panel section was in good condition with no noticeable settlement. The corners of several existing concrete panels were chipped and slightly shifted between concrete piles. No other structural damage noted.
Construction Unit No. 1 of the Barataria Landbridge Shoreline Protection Project consists of the installation of 1,600 linear ft. of shoreline protection along the west bank of Bayou Perot and 1,600 linear feet of shoreline protection along the southeast bank of Bayou Rigolettes. Each location consists of four types of shoreline protection features. Below is a discription of the features constructed at each site.					Attached is the settlement data obtained over the lifetime of the demo sections collected by NRCS.

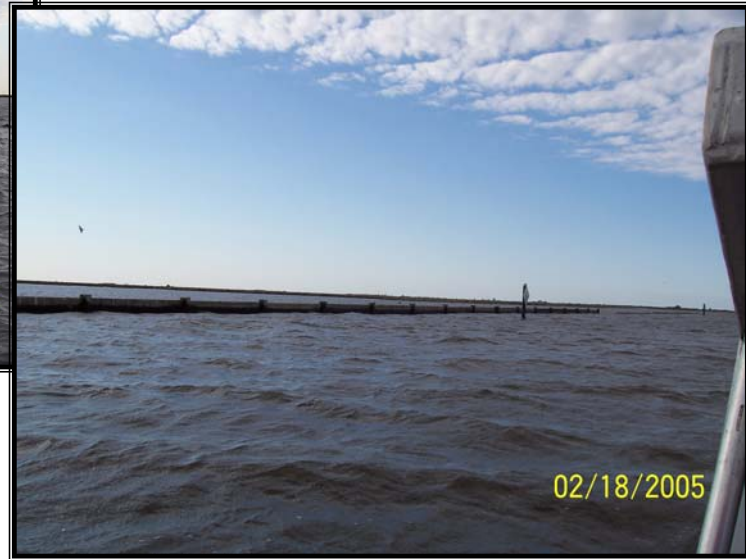
BA-27 (Construction Unit No.1) 400 linear ft (122 m) concrete pile and panel wall located on the east bank of Bayou Rigolettes looking southeast.

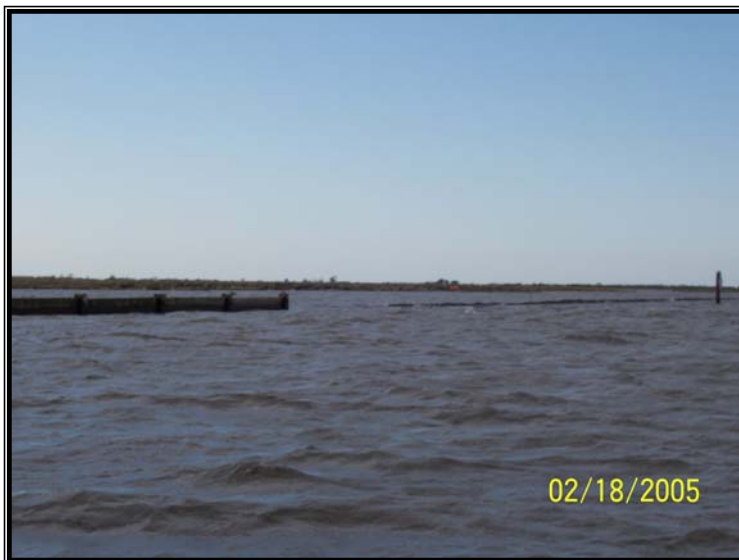
Section A and A1 – From a visual inspection and review of settlement plate data, it appeared that the rock dike has settled considerably since the completion of construction.

BA-27 (Construction Unit No.1) concrete pile and panel wall and 200 linear ft (61 m) of rock dike with geotextile fabric and another 200 linear ft w/o geotextile fabric along east bank of Bayou Rigolettes looking southeast.

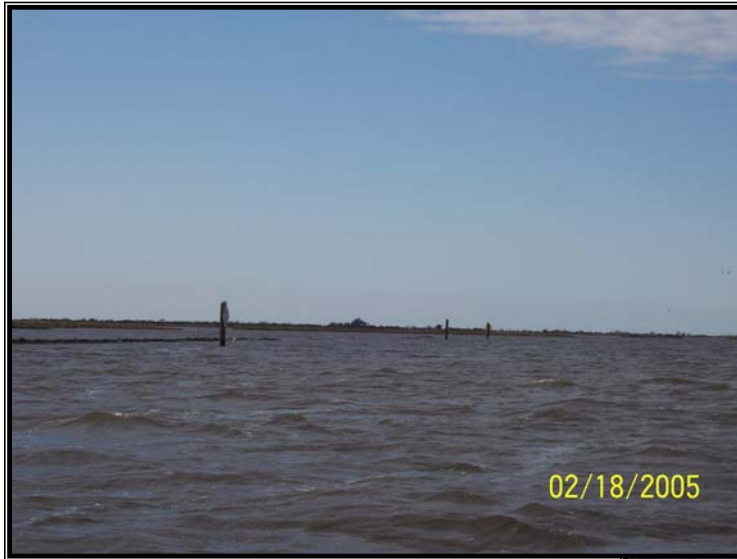
BA-27 (Construction Unit No.1) end of 200 ft (61 m) rock dike with and without geotextile fabric and beginning of composite rock dike along east bank of Bayou Rigolettes looking southeast.

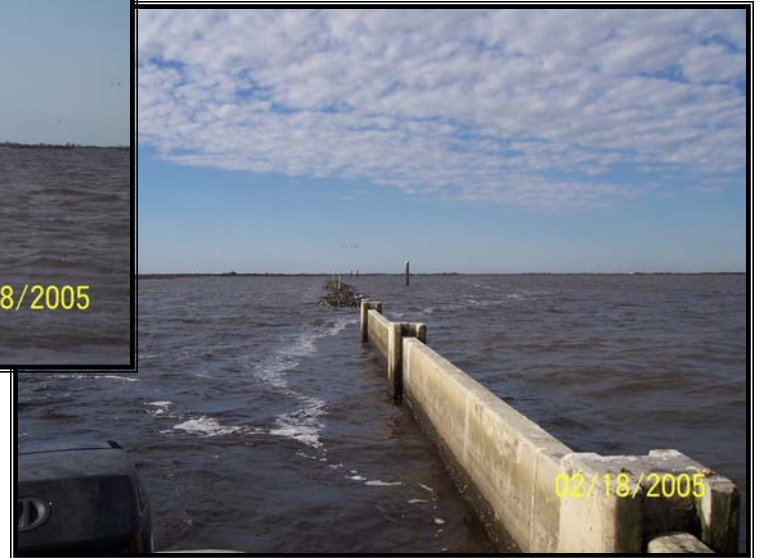
BA-27 (Construction Unit No.1) 400 linear ft (122 m) concrete pile and panel located along east bank of Bayou Rigolettes looking southwest.

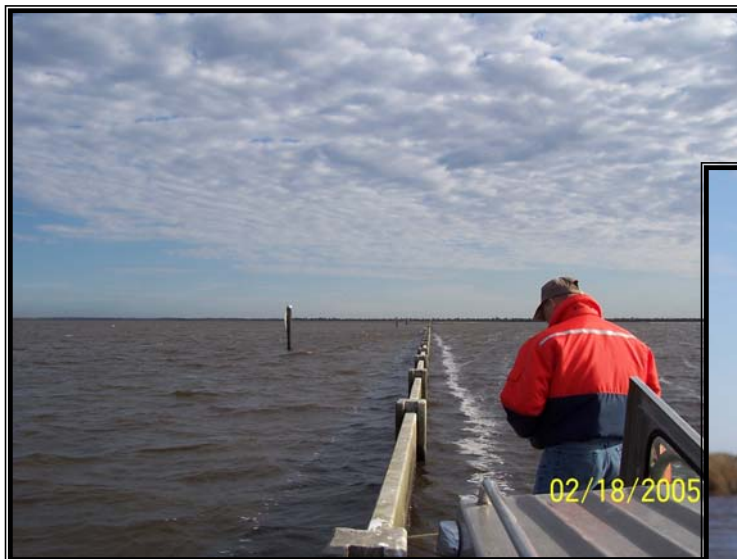
BA-27 (Construction Unit No.1) 400 linear ft (122 m) concrete pile and panel wall located along the east bank of Bayou Rigolette looking northeast.

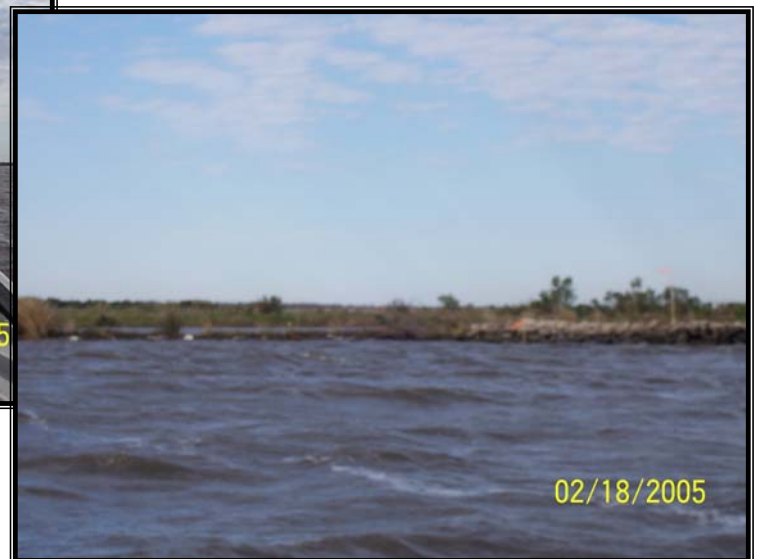
BA-27 (Construction Unit No.2) Beginning of rock dike located along the west bank, at the mouth of the Harvey Cutoff Canal looking west.

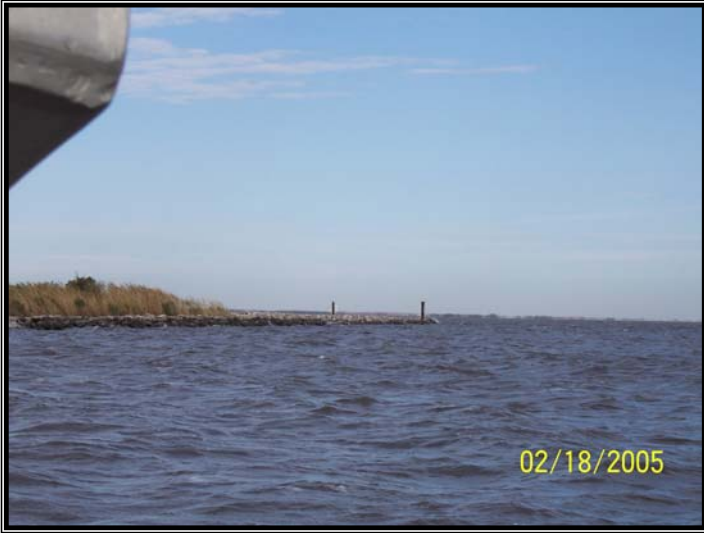
BA-27 (Construction Unit No.2) Beginning of the rock dike located at the mouth of the Harvey Cutoff Canal along the west bank looking northwest.

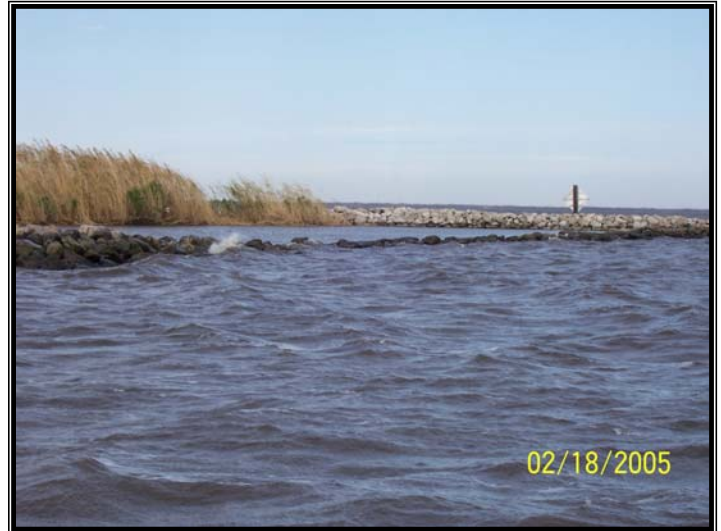
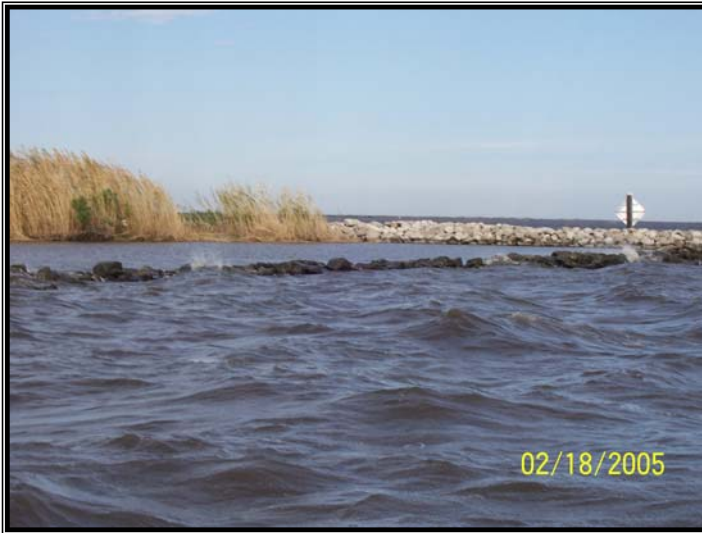
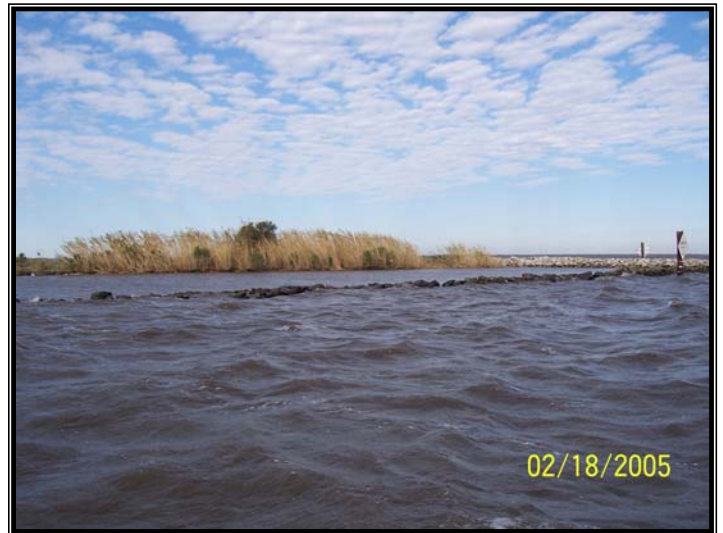
As noted in the 2004 annual inspection report, we observed settlement along the rock dike at Station 31+00 at the mouth of the Harvey Cutoff Canal and near an existing pipeline right-of-way at Station 12+33. The crest elevation at these locations appeared to be between the elevations of +1.0 to +1.5 ft NAVD. Due to poor soil conditions at these two locations, the contractor constructing the project was unable to raise the rock dike to plan elevation after several attempts. The conditions of the rock dike at these locations mentioned above appear to have stabilized and no immediate maintenance is required at this time (see Appendix A – Photographs).

BA-27 (Construction Unit No.2) low area along the rock dike located at the mouth of the Harvey Cutoff Canal looking northwest.

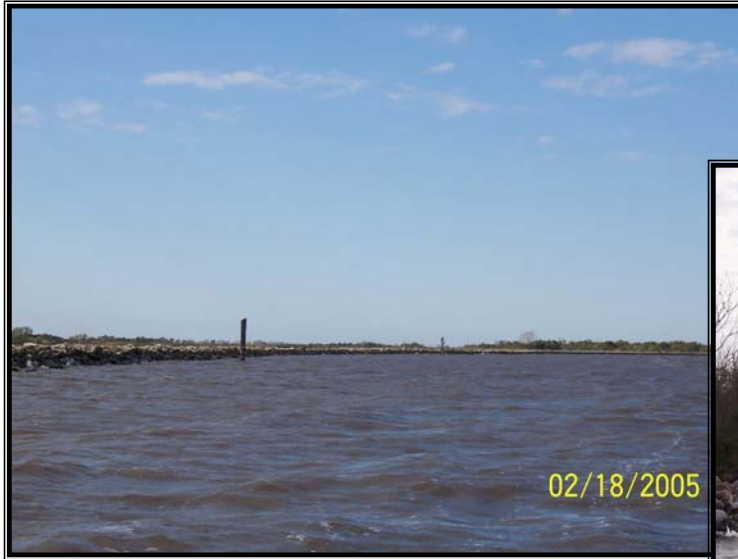
BA-27 (Construction Unit No.2) rock dike located along the southern bank of Bayou Rigolettes entering Bayou Perot looking west.

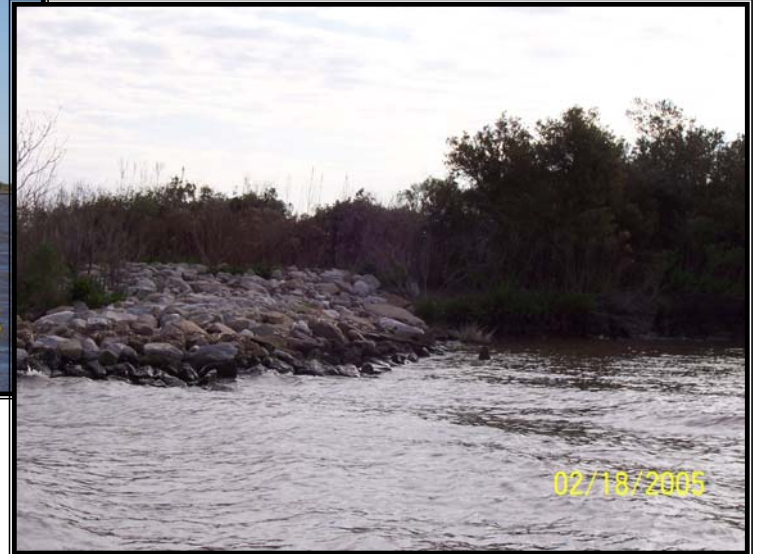
BA-27 (Construction Unit No.2) end of the east reach of CU 2 located at the mouth of an existing location canal along the east bank looking northeast.

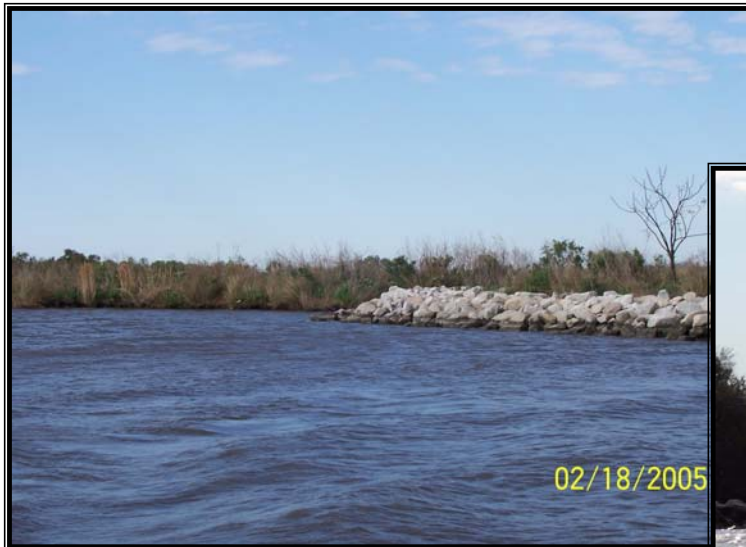
BA-27 (Construction Unit No.2) beginning of west reach of CU 2 located at the mouth of an existing location along the west bank looking west.

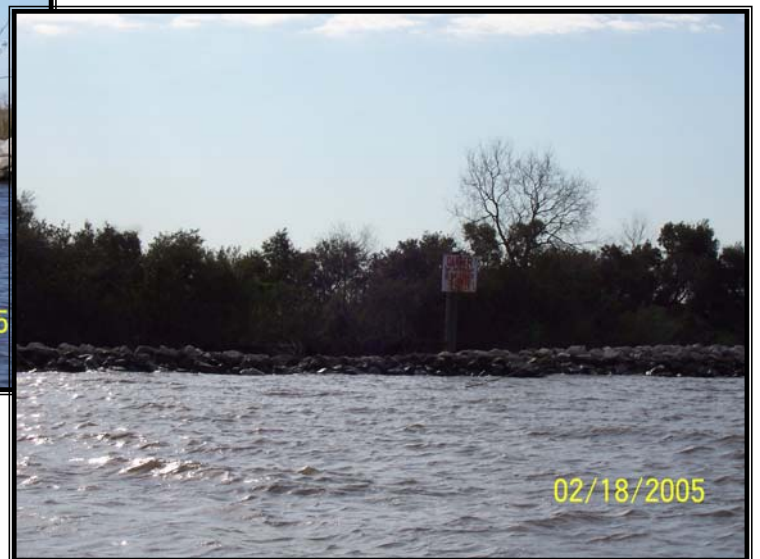
BA-27 (Construction Unit No.2) rock riprap dike (west reach) located along the south bank of Bayou Perot looking south.

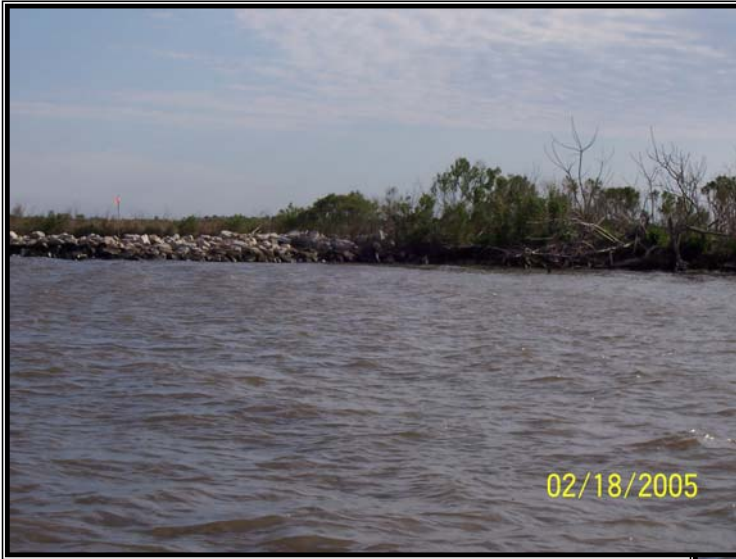
BA-27 (Construction Unit No.2) end of west reach of CU 2 located along the south bank of Bayou Perot looking east.

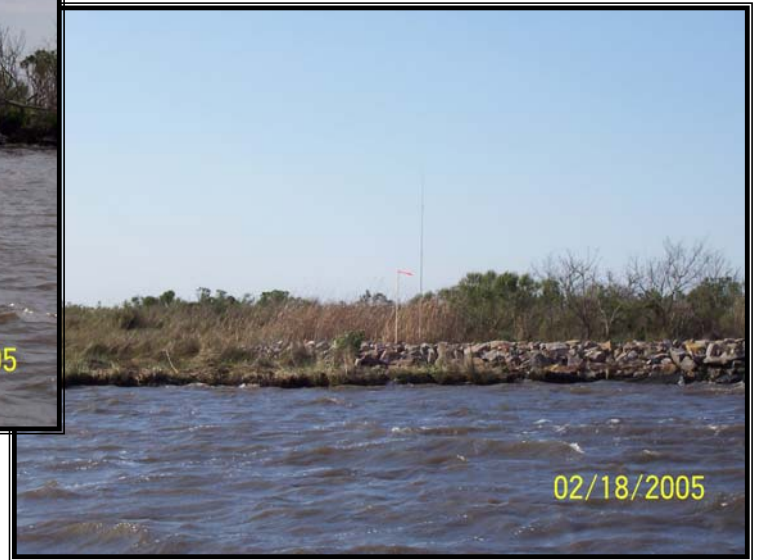
BA-27 (Construction Unit No.3) Beginning of rock riprap dike located at the mouth of Bayou Perot near Little Lake on the south bank looking east.

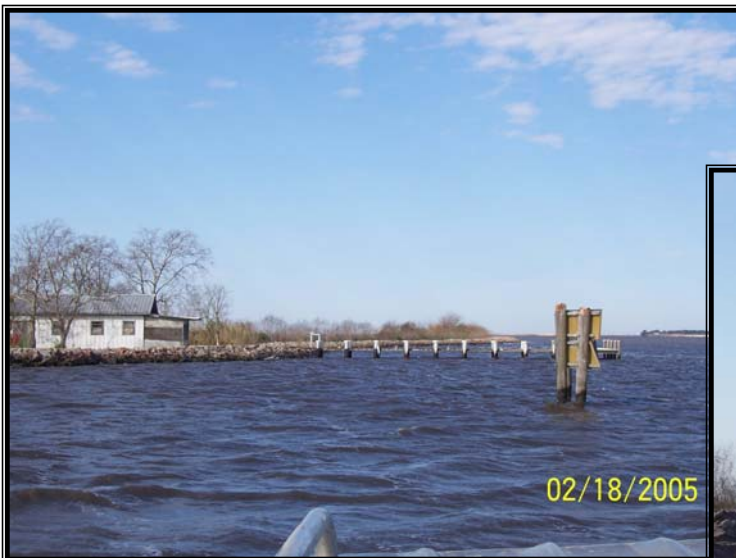
BA-27 (Construction Unit No.3) rock riprap dike located near an existing camp along the south bank of Bayou Perot near Little Lake looking west.

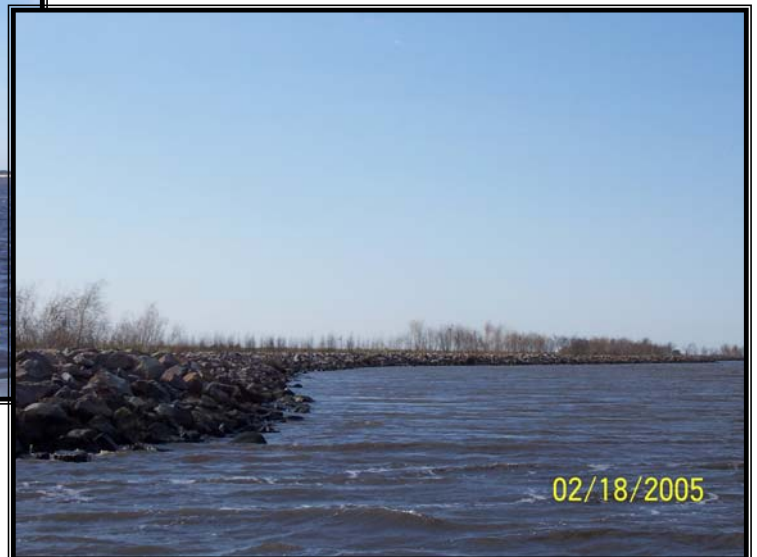
BA-27 (Construction Unit No.3) rock dike located along the northeast bank of Little Lake south of Bayou Perot looking south.

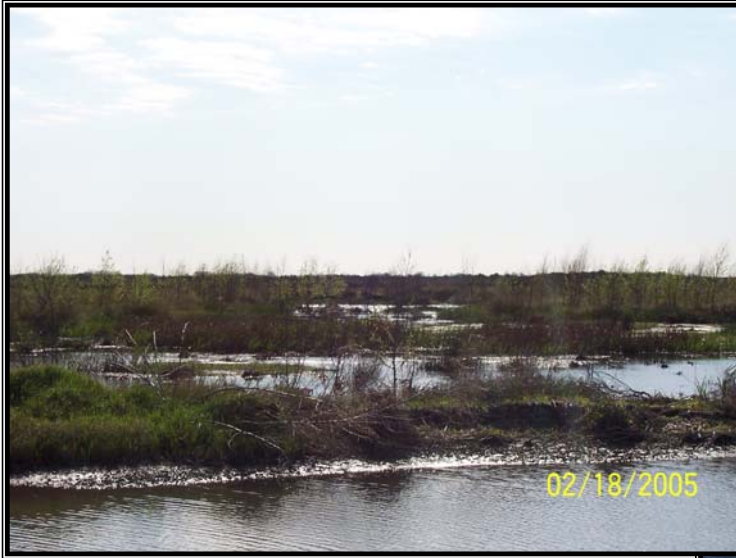
BA-27 (Construction Unit No.3) shallow pond areas in which material from dredging of flotation was used to create marsh.

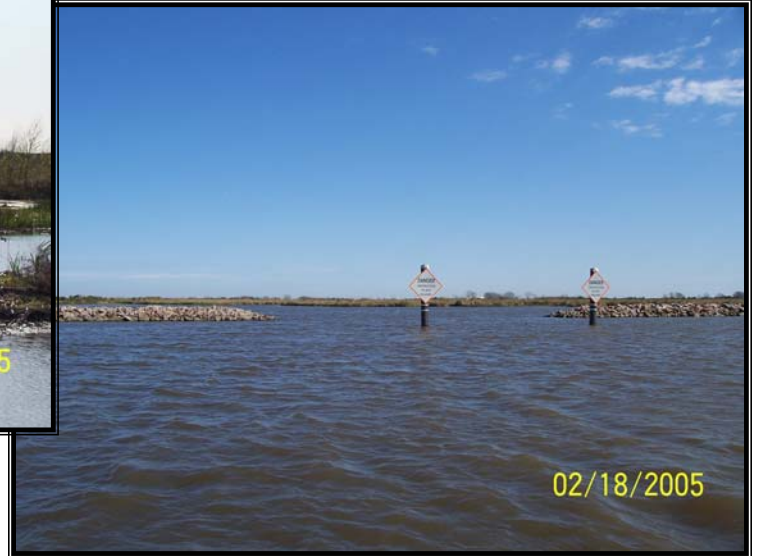
BA-27 (Construction Unit No.3) fish dip along rock riprap dike located along the northeast bank of Little Lake looking north.

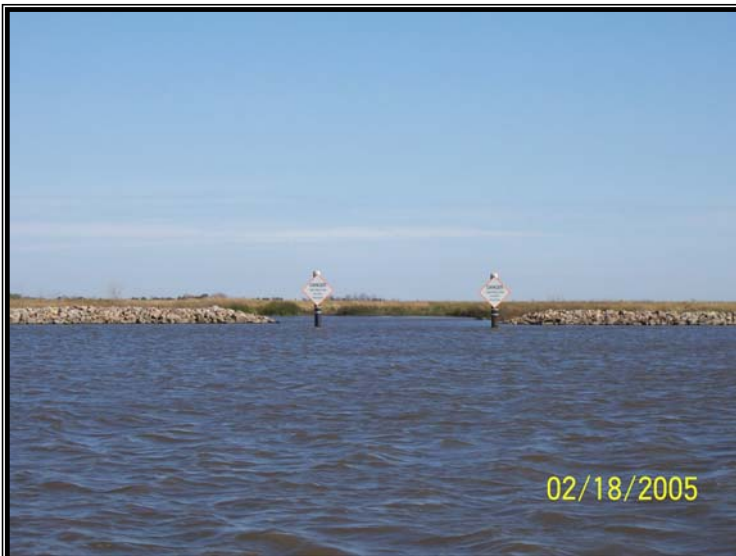
BA-27 (Construction Unit No.3) fish dip location along the rock riprap dike located along the northeast bank of Little Lake looking north.

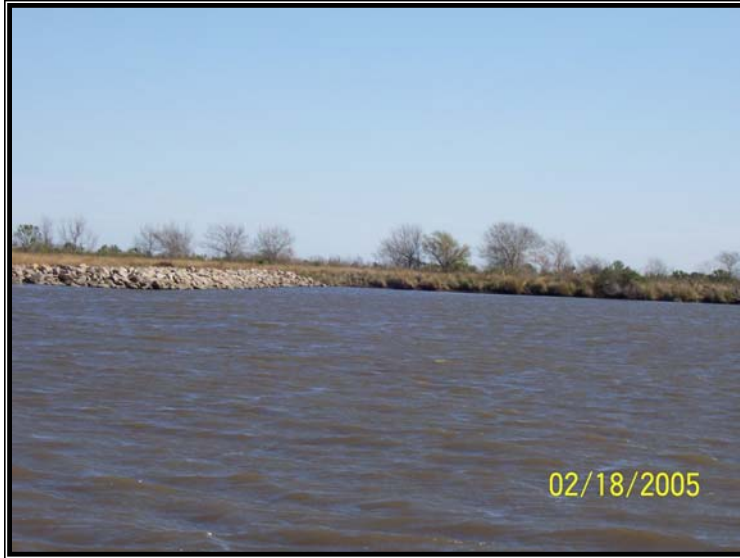
BA-27 (Construction Unit No.3) end of CU 3 rock rip rap dike.
